# PUBLIC ROADS

# AERIAL SURVEYING ON THE ALASKA HIGHWAY, 1942

Reported by WILLIAM T. PRYOR, Highway Engineer,<sup>1</sup> Department of Design, Public Roads Administration

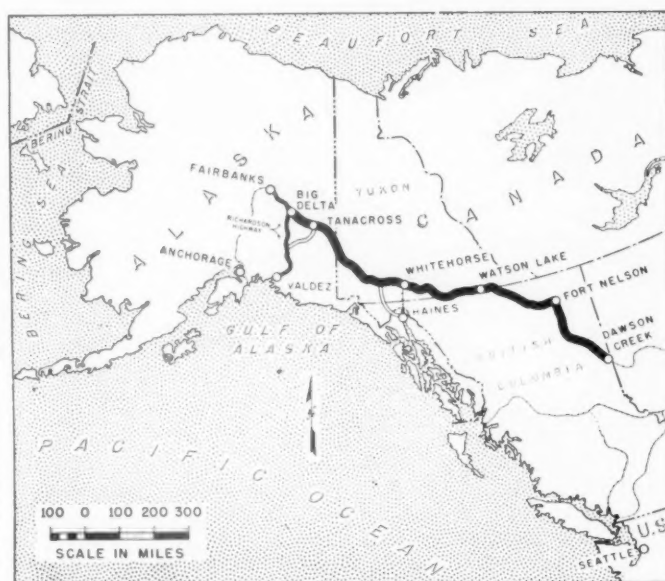
FIGURE 1.—MAP OF THE ALASKA HIGHWAY.

division, with headquarters at Fort St. John, extended 634 miles from Dawson Creek to a point near Watson Lake; the northern division continued from that point for 789 miles to Big Delta, and had its headquarters at Whitehorse (fig. 1).

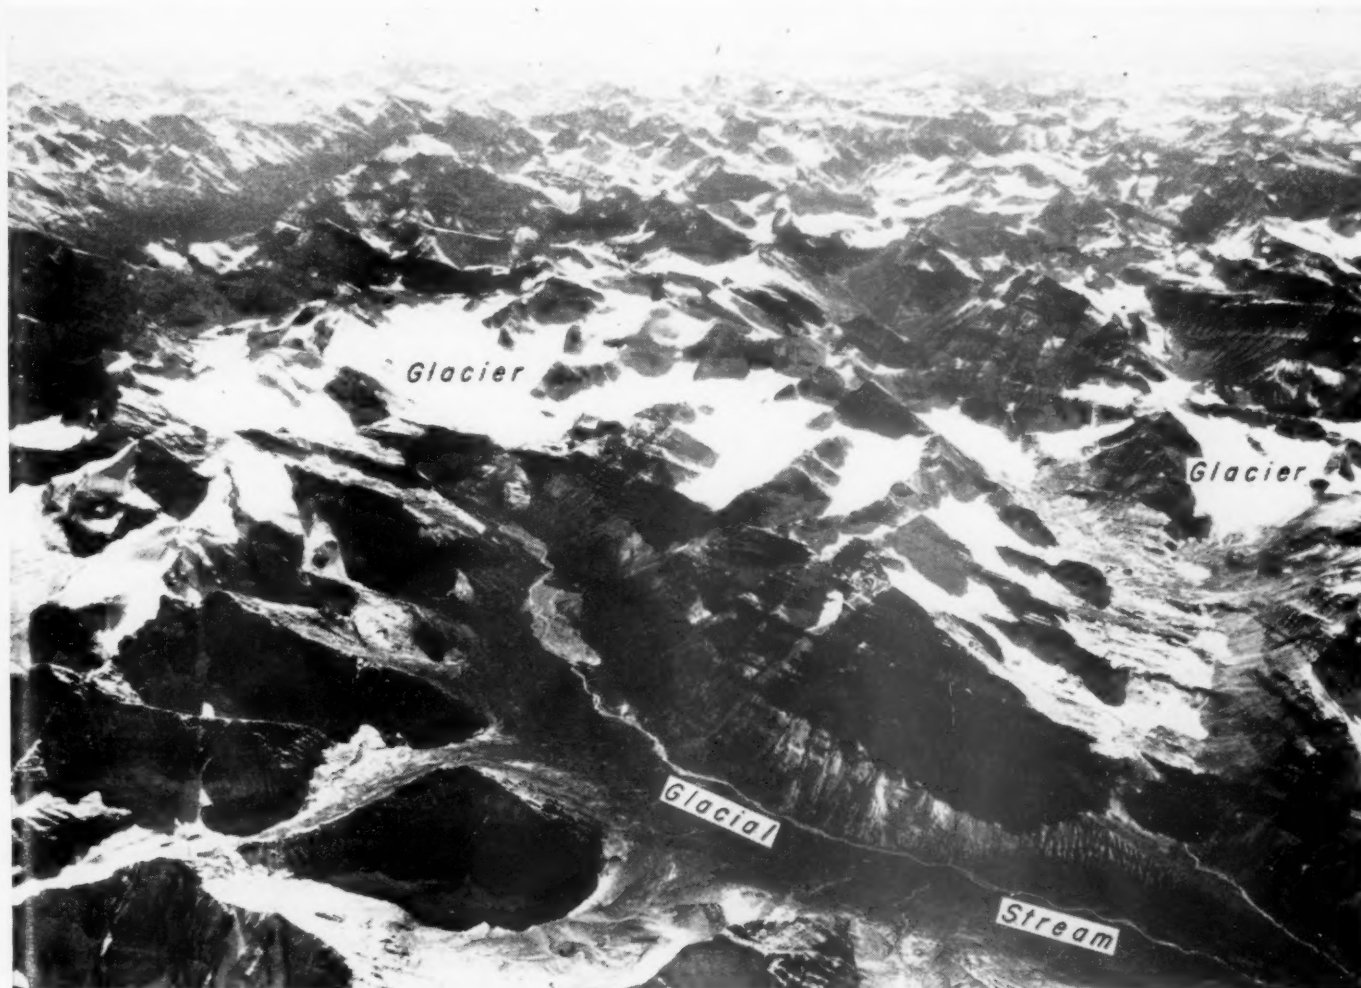
FIGURE 4.—IMPASSABLE TOPOGRAPHY—HIGH MOUNTAINS AND GLACIERS.

*Impassable topography.*—In impassable topography a road suitable for all-year use could not be built in a reasonable length of time. Figure 4, showing a section of the Canadian Rockies about 100 miles southwest of Fort Nelson, illustrates this type of topography.

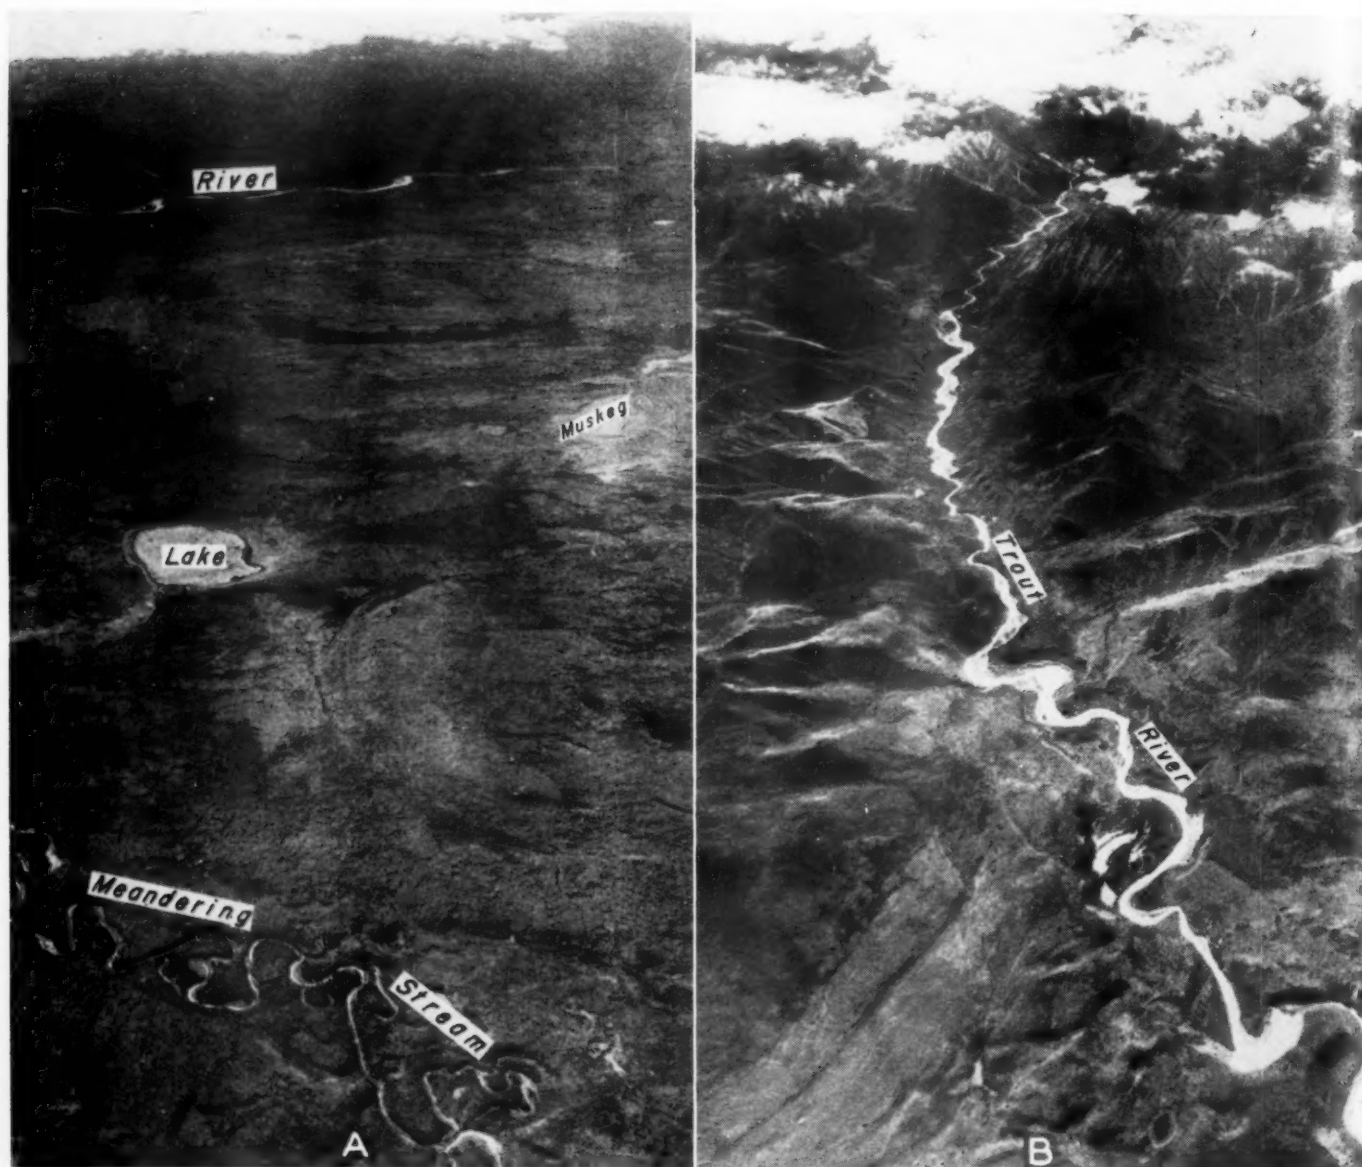
FIGURE 5.—DIFFICULT TOPOGRAPHY—(A) MUSKEG ON LEVEL GROUND, AND (B) A NARROW, TORTUOUS RIVER VALLEY.

*Difficult topography.*—In this kind of topography special problems are encountered in locating and building a road. In the area north of the Canadian Rockies, shown in figure 5, A, the ground is fairly level as indicated by the numerous small lakes and the ox bows in the rivers; but there are many areas of muskeg, composed of water-saturated muck, fine silty soil, and decaying vegetation with a cover of moss, grasses, willows, and low-growing bushes. Stunted evergreens often grow scatteringly on these areas. Muskeg is an extremely

unstable base for road building. It occurs not only in valleys and on level ground, but also on hillsides wherever water is retained. The subsoil underlying muskeg is always impermeable and frequently is permanently frozen (permafrost).

A different type of difficult topography is shown in figure 5, B, a photograph of the Trout River valley near its confluence with the Liard. The river flows north out of the Canadian Rockies through rugged ground. The highway was built along this river valley, and tortuous alinement and steep grades were necessary. Water seeping and flowing down the slopes under a cover of vegetal debris caused slides in spring and summer and formation of ice in winter.

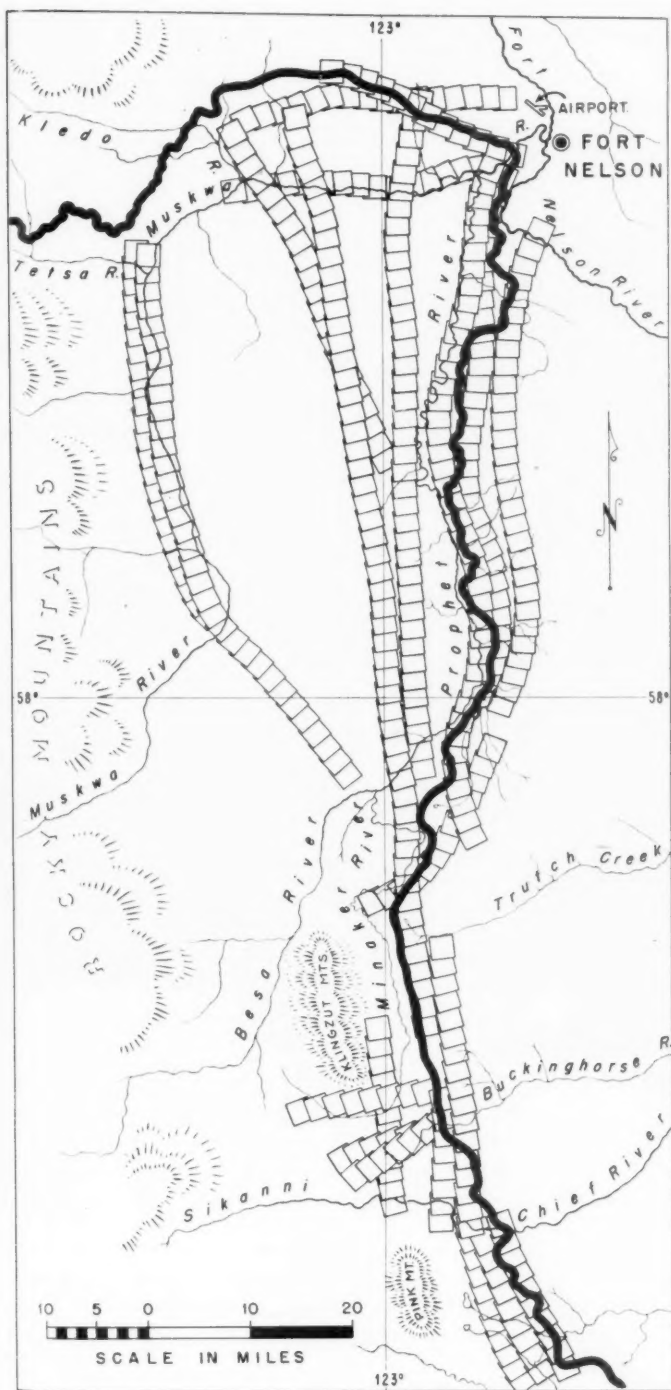
FIGURE 11.—LOCATION OF SOME OF THE FLIGHT LINES AND VERTICAL PHOTOGRAPHS TAKEN ALONG THEM ON ONE SECTION OF THE ALASKA HIGHWAY.

Figure 11 shows the locations of some of the vertical photographs taken on flights along possible routes chosen for detailed study in the area south and west of Fort Nelson—only every other photograph of each flight line is represented, and some flight lines are omitted altogether, in order to avoid crowding. The overlaps and gaps in the flight lines reflect the haste with which the photography was necessarily done, and the inability to plan the work completely in advance because of the lack of suitable maps such as would be available for similar work in the United States.

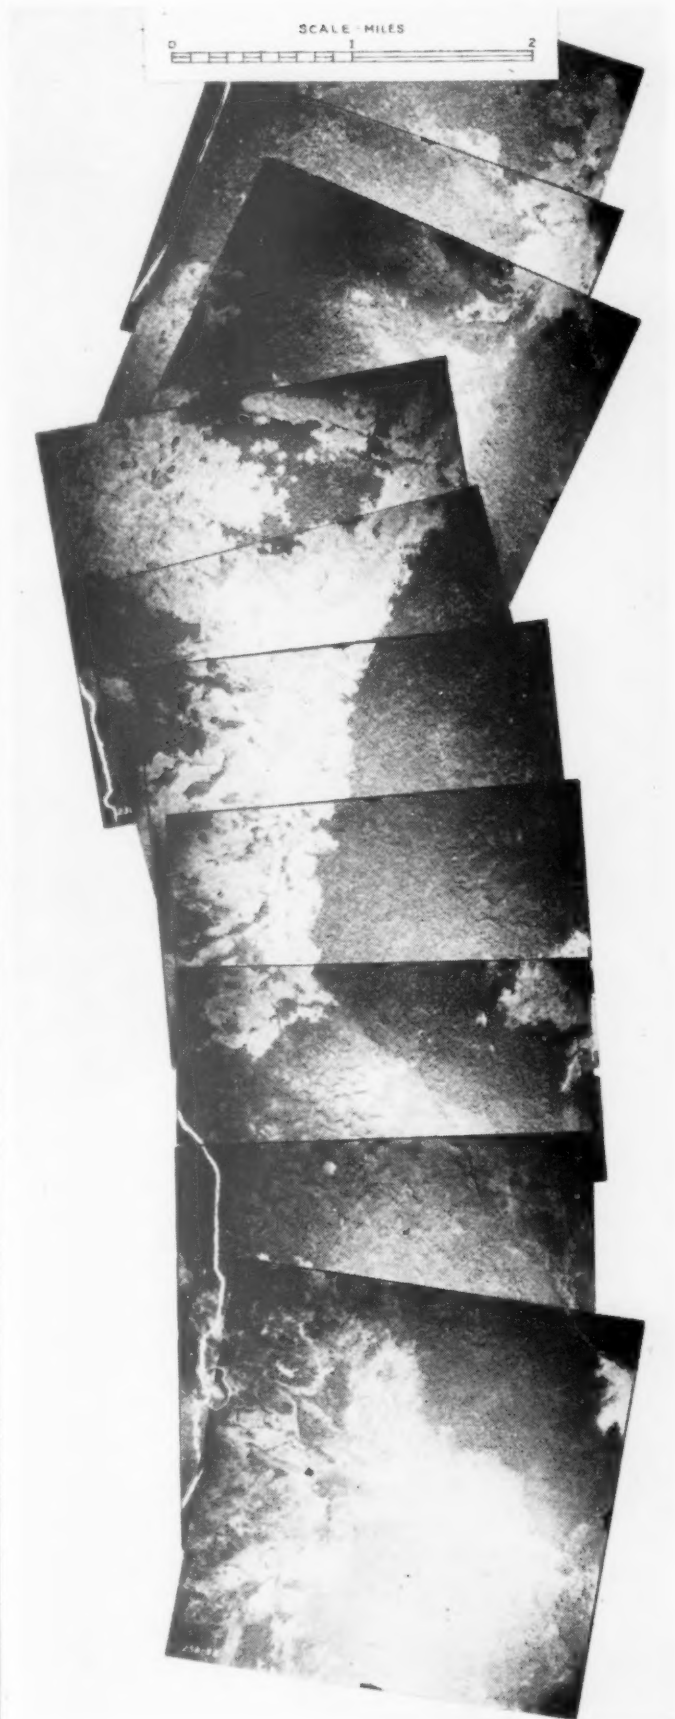
FIGURE 12.—AN UNCONTROLLED MOSAIC MADE BY MATCHING A SERIES OF VERTICAL PHOTOGRAPHS.

Uncontrolled mosaics were made simply by matching the conjugate images of adjacent vertical photographs, as shown in figure 12. The pioneer road had already been pushed through this area, and appears as a white line on the edges of some of the photographs. An uncontrolled mosaic made from verticals taken on several

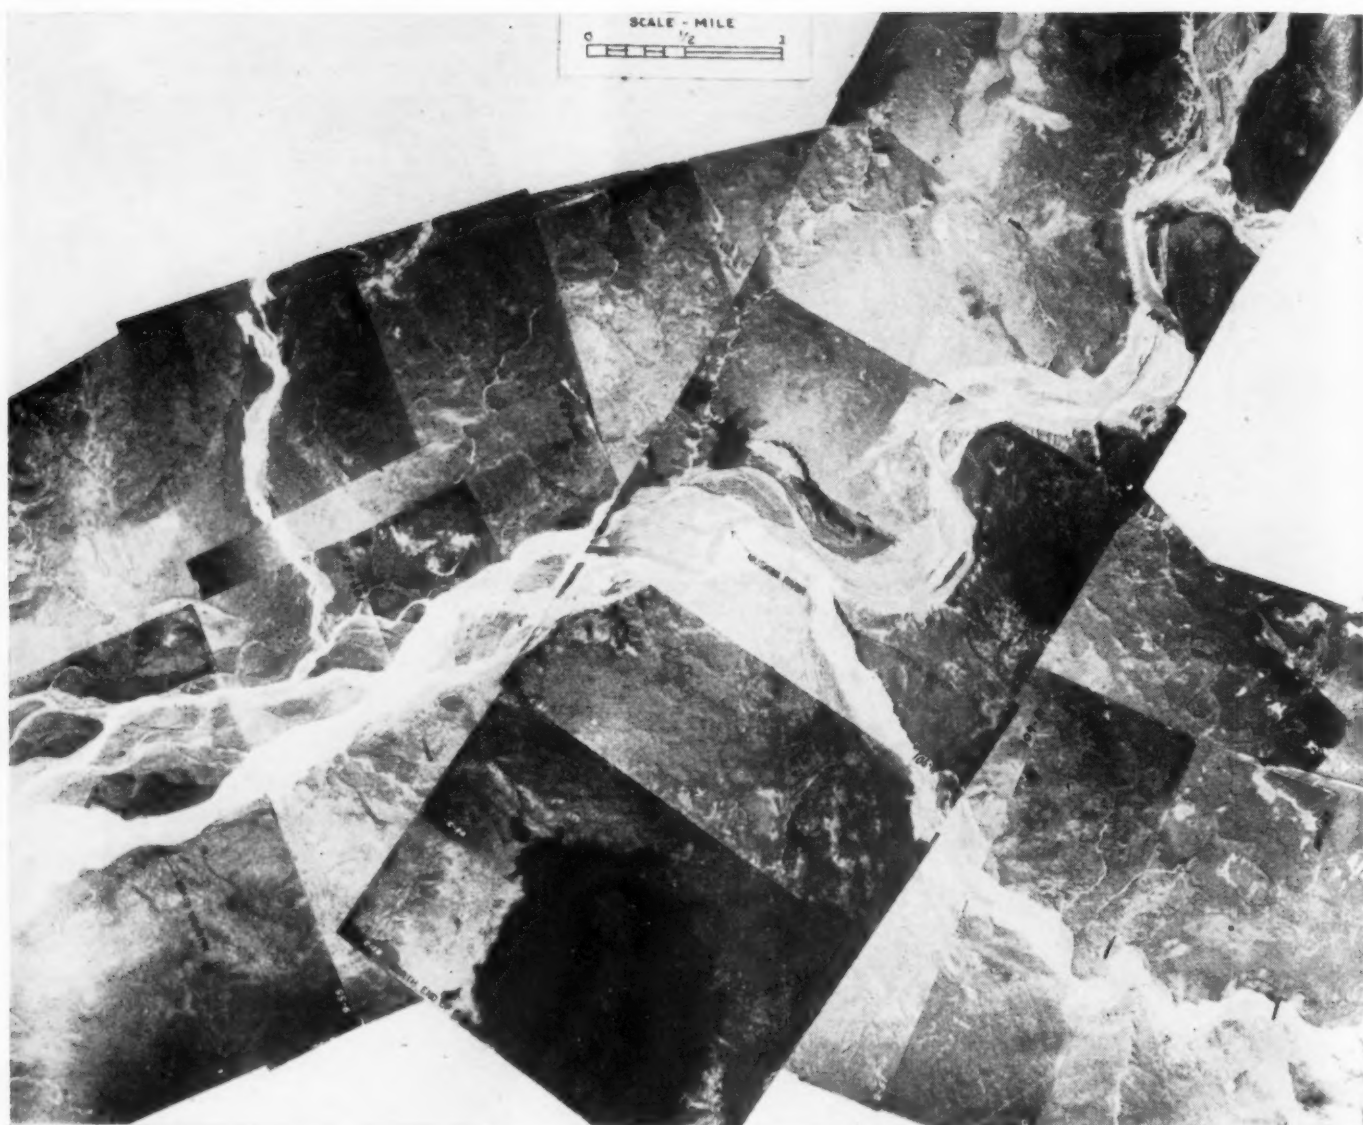
FIGURE 13.—AN UNCONTROLLED MOSAIC MADE OF PHOTOGRAPHS FROM SEVERAL OVERLAPPING FLIGHTS.

overlapping flights is shown in figure 13. These pictures show the area at the confluence of the Tetsa and Muskwa Rivers.

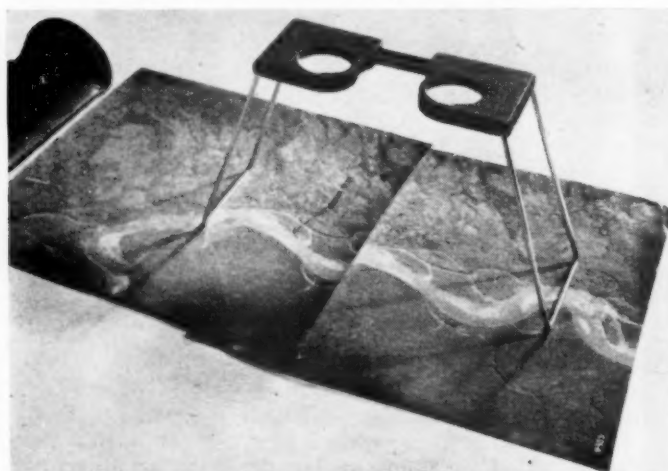
FIGURE 14.—AN ENGINEER'S STEREOSCOPE—AN AID IN SEEING PICTURED TOPOGRAPHY IN RELIEF.

stereoscope shown in figure 14 set up over a pair of photographs, are now available for engineers. When properly oriented, spaced, and mounted the pair of photographs, covering the same area but taken from different camera positions, is called a stereogram.

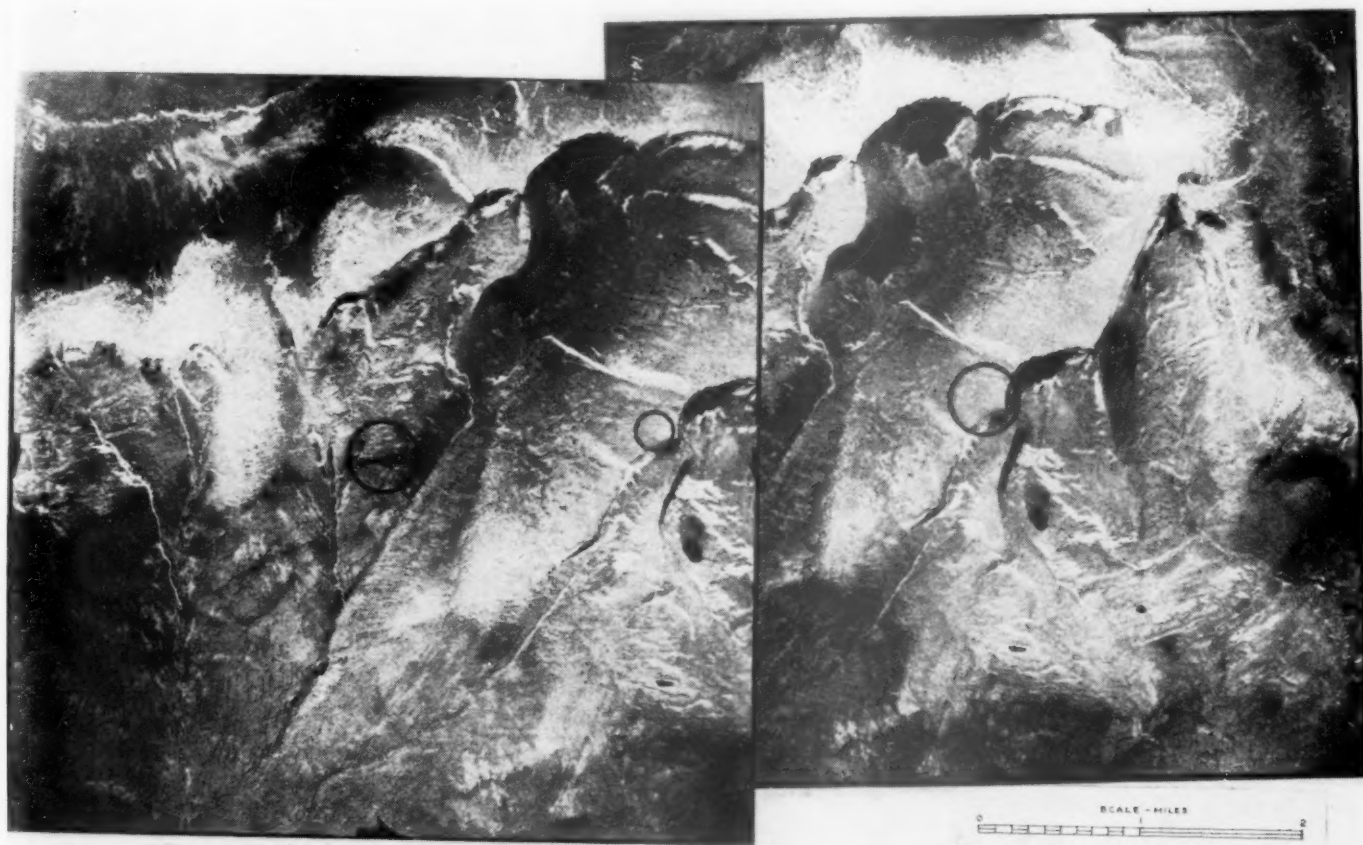
FIGURE 15.—A TYPICAL STEREOGRAM—A PAIR OF PHOTOGRAPHS ORIENTED FOR STEREOSCOPIC STUDY.

10 or 12 inches high should be placed on edge along the dividing line between the two photographs of the stereogram. A well-defined feature should be selected as a focal point: For example, the small lake in figure 15 which appears below the circled center in the right photograph and the circled transferred center in the left photograph. The forehead is rested on the top of the cardboard, with each eye looking at the selected point on the photograph beneath it. Both eyes must be focused as though looking beyond the plane of the stereogram until the chosen points appear to fuse together. The entire area within view will then be seen in three dimensions.

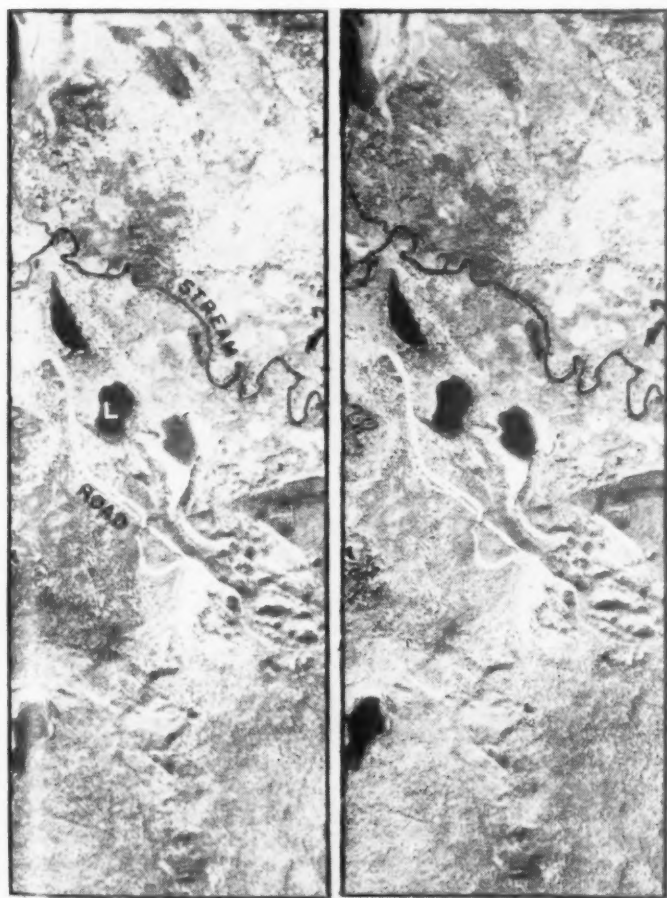
FIGURE 20.—GLACIAL DEPOSITS ARE EVIDENT IN THIS STEREOGRAM.

The stereogram, figure 20, shows glaciated topography with scattered evergreen groves. The eskers and drumlins among the small lakes cause the appearance of "pockmarks" and "knob and kettles." Glacial deposits of this character are definite signs of materials suitable for road building. The pioneer road can be seen in this picture winding across the rough topography. The more direct alinement built subsequently can also be seen.

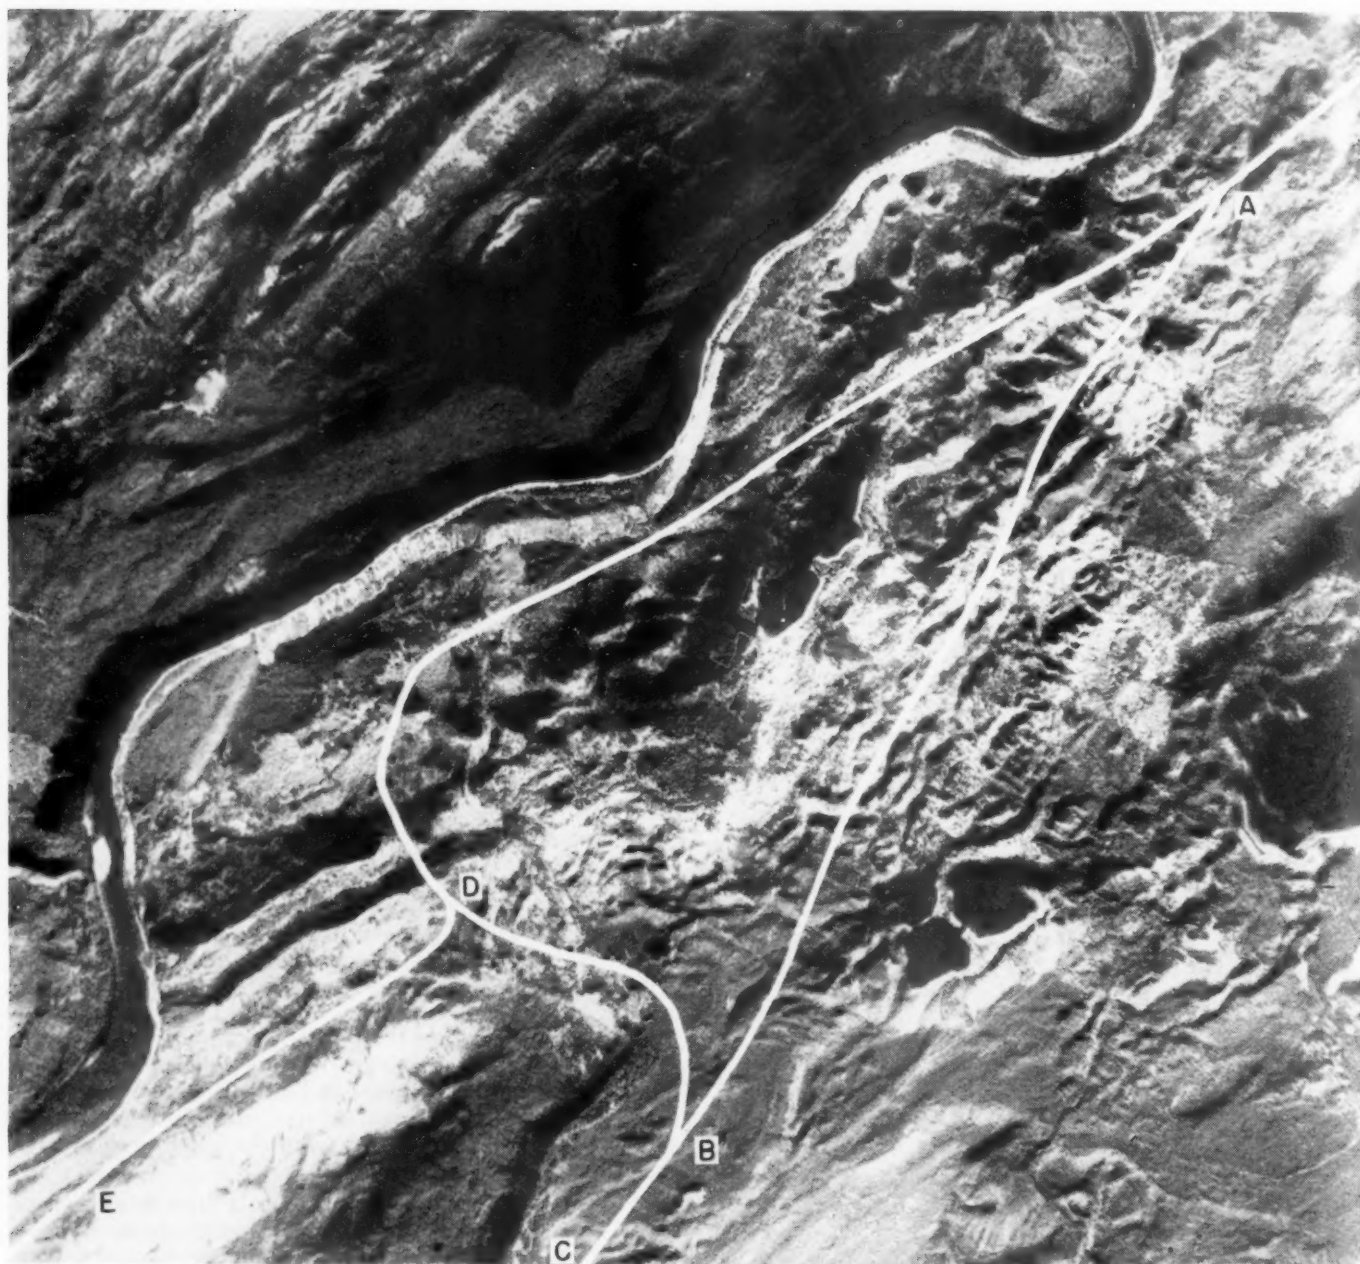
FIGURE 22.—TENTATIVE LOCATIONS SELECTED ON A PHOTOGRAPH.

Each trial line was then studied in detail and was adjusted to the topography and to soil and drainage conditions as seen and interpreted by stereoscopic examination of successive pairs of photographs. The final lines were then drawn with a wax crayon on each vertical as illustrated in figure 22, which shows a glaciated area along the Rancheria River. The line had already been located to point A by study of adjacent photographs. From this point there are several possibilities: Route A-B-C is direct but crosses irregular ground; route A-D-E is longer but lies on fairly smooth topography; an alternate A-D-B-C combines parts of the two routes. The choice of going through E or C would depend on study of adjoining photographs.

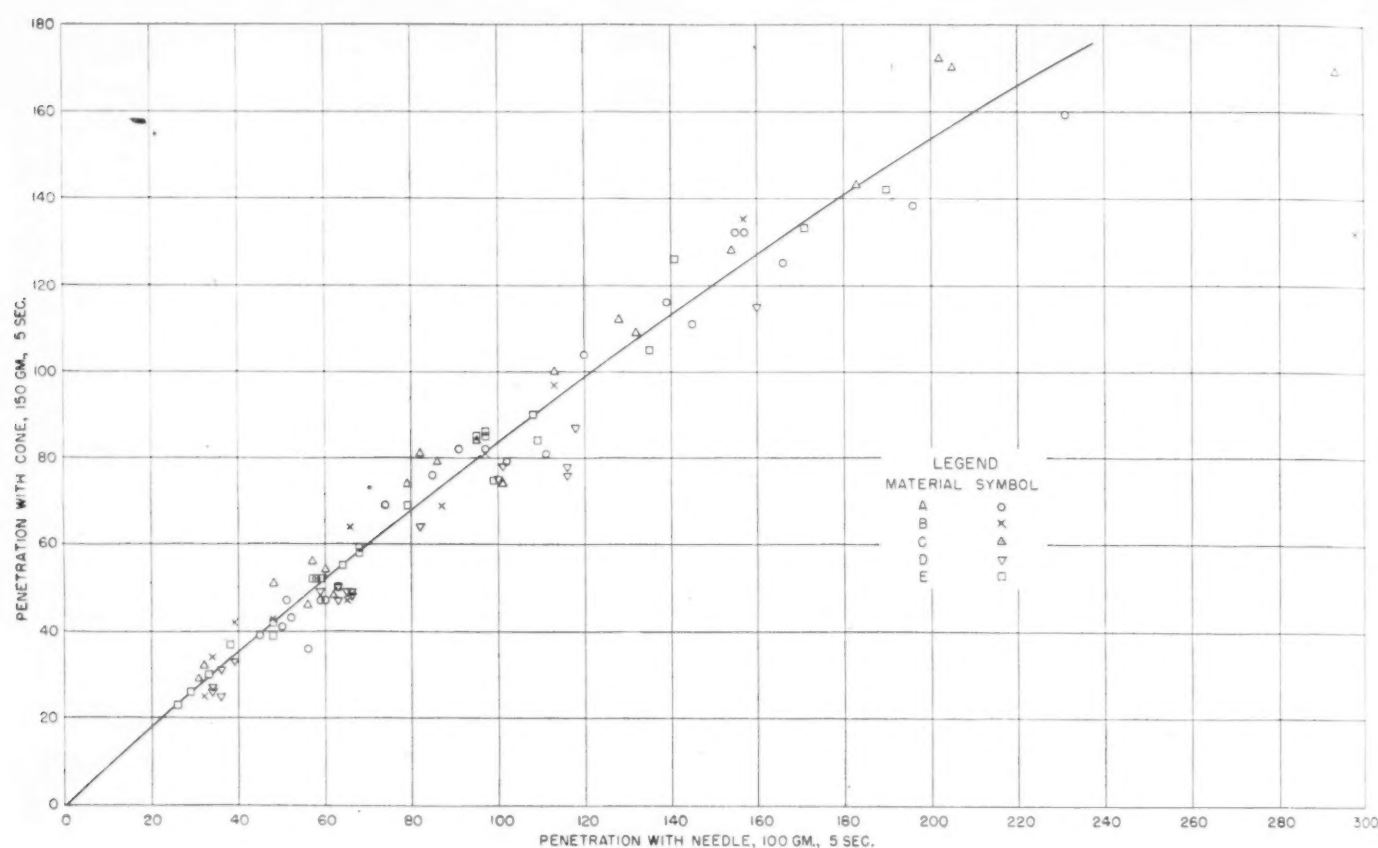
FIGURE 1.—RELATION BETWEEN PENETRATION WITH GREASE CONE AND STANDARD NEEDLE.

The cone penetrometer, which is required by Federal Specification SS-F-336 for the determination of the consistency of these asphalt-rubber blends, was devised initially for the control of greases and petrolatum. It

has been used, however, for determining the consistency of calking materials and other materials of nonuniform texture. The first rubber-asphalt joint-filling materials contained vermiculite or other flaky matter which to a certain extent prevented close checking of consistency with the standard asphalt penetration needle. It was found in this study that if the same number of tests are made with the standard penetration needle as are required by the A. S. T. M. method for the cone penetrometer, an average of the results is a satisfactory measure of the consistency of the filler material.

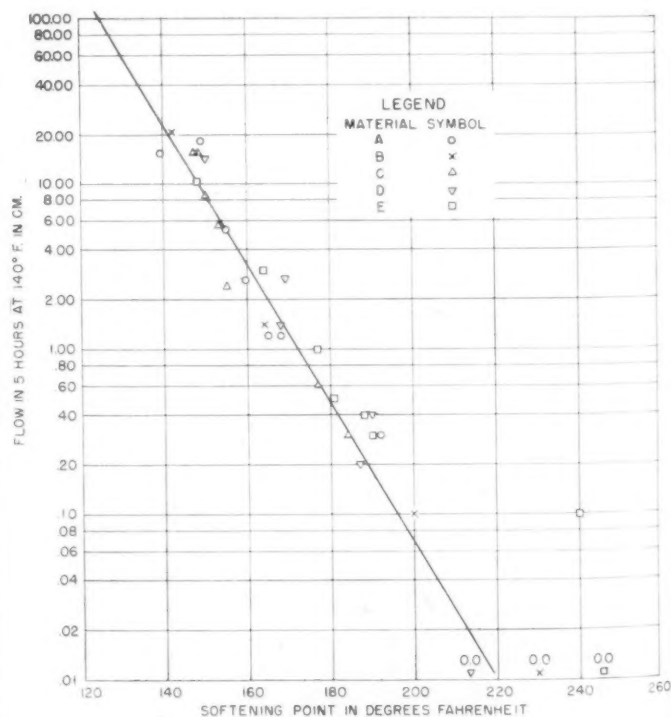
FIGURE 6.—RELATION BETWEEN SOFTENING POINT AND FLOW.

The softening point determination is most useful for the control of standard bituminous materials, both asphaltic and tar products. It is especially valuable in determining the resistance of these materials to the softening action of the sun or of artificial heat. It has been used, therefore, as a measure of the changes occur-

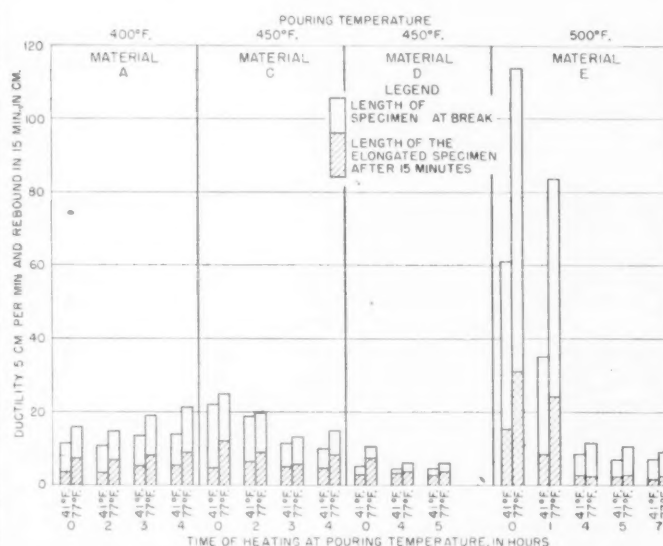
FIGURE 8.—EFFECT OF TIME OF HEATING AT MINIMUM SUITABLE POURING TEMPERATURE ON DUCTILITY AND REBOUND AT 41° F. AND AT 77° F.

The effect of time of heating on the ductility of these materials is shown in figure 8. In the case of sample A the ductility tends to increase as time of heating increases, but with the other materials the ductility tends to decrease as the time of heating increases. The latter effect is especially true of sample E. The drop in ductility after 1 hour of heating is sufficient to indicate a definite change in structure and as the heating continues the ductility values are lower

than those obtained on any of the materials except sample D. Sample E, on heating to 500° F., develops ductility at 77° F. comparable to that of a steam-refined asphalt of comparable consistency. When tested at 41° F., the ductility is considerably higher than for an asphalt cement of comparable consistency. When this material is held at 500° F. for long periods, the ductility is reduced below the values obtained on the same material when heated to 400° and 450° F.
